Landlords / Homeowner Gas Safety Record - G2

Plumbing Condition Report

Central Heating Condition Report

Accompanying Photos

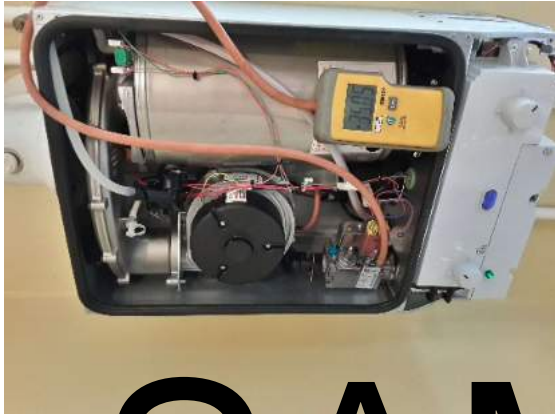
Description: Boiler

Boiler Details				
Boiler- Make	Model:	Approx Age in years	Type of Boiler	Location
Worcester	Greenstar 12 Ri Lpg	3+		Kitchen

Item tested	Result	Comments
Boiler Condition	Good	
Central heating pump	N/A	Located in loft
Heating control and timer	Fair	Honeywell. Hot water not working
Room Thermostats	Fair	Honeywell
Earth bonding to pipework and boiler	N/A	
Motorised Valve(s)	Fair	Heating working
Feed/Expansion tank insulation	Good	Lagged and lid fitted
Fuel Storage Tank and pipe work	N/A	
Discharge/Condense Pipe	Good	
Drain off cock	Fair	Some rads have no drain off valves
TRV (Thermostatic Radiator Valves)	Fair	All working

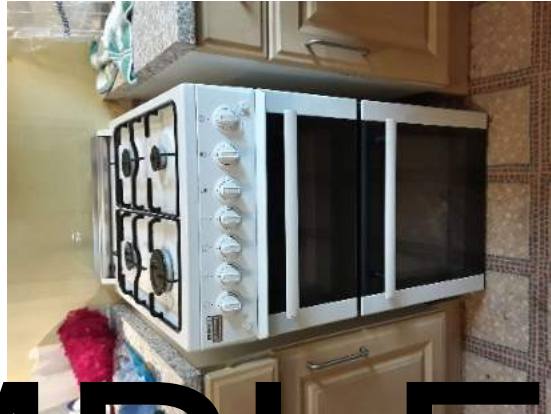
Description: Cooker

Condensing Boiler	Cooker
Location	kKitchen	Kitchen
Make	Worcester	Beko
Model #	Greenstar 12Ri Lpg	N/F
Serial #	55707540000137733600075	N/A
Flue Type	Room Sealed	Room Sealed
Safety Device	Pass	Pass
Operating Pressure/Gas Rate	35.00 mbar	35.00 mbar
Ventilation Adequate	Yes	Yes
Flue Flow Test	N/A	N/A
Spillage Test	N/A	N/A
Termination Satisfactory	Yes	N/A
Visual Condition	Pass	Pass
Appliance Serviced	No	No
ID, AR or Advisory situation	N/A	N/A
Gas Council Number	41-406-42	N/F
Flue Gas Analysis (Ratio)	0.0016	N/A - This appliance is not a boiler
Safe To Use	Yes	Yes
Appliance related comments:	No engineer comment	No engineer comment

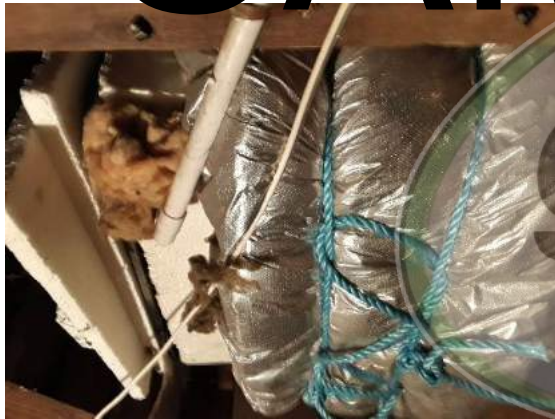
Description: Loft

Item tested	Condition	Comments
Hot Water Storage	Fair	Located in the loft has a lagging jacket
Operation of immersion elements	Fair	Switch is located in hallway
Cold Water Storage Tank	Fair	Plastic tanks with lids and lagging jackets
Water flow rate Main.	Fair	Tank for hot water and bathroom Mains pressure cold water to part of the system
Low Pressure	Fair	
Stopcock		Located in a kitchen cupboard is working and good condition
Outside tap.	Fair	No non return valve fitted

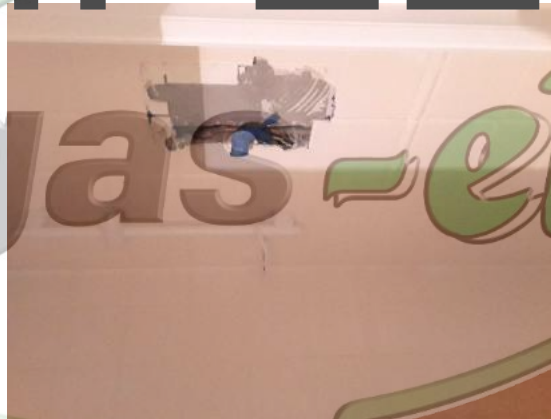
Description: Shower

Item tested	Condition	Comments
Hot Water operates effectively	Fair	Some taps could do with replacing
Kitchen sink & plumbing	Fair	Taps and sink are good as is visible plumbing
Utility room & plumbing	N/A	
Washing machine etc. & plumbing	N/A	
Dishwasher & plumbing	N/A	
Ground floor WC & plumbing	Fair	The WC's and sink and bath are in good condition The taps in bathroom should be replaced
En suite other	N/A	
Family bath room & Plumbing	Fair	Taps in poor condition
Condition of baths & showers	Good	Electric shower has been removed Bath in fair condition

Overall condition: For the age or the property the condition is fair.
 Some plumbing needed (taps & shower)
