Legionella Risk Assessment

Landlords / Homeowner Gas Safety Record - G2

Annual Electrical Safety Record - E2

Appliance Service Record

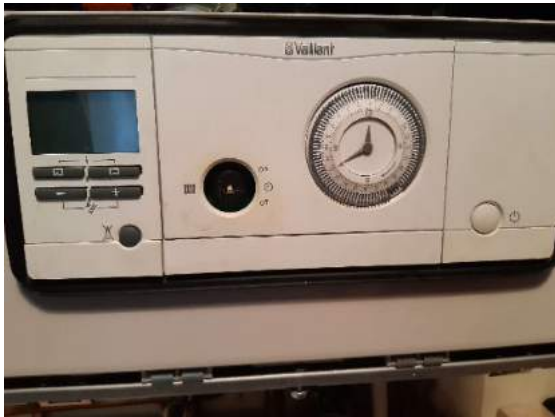
Engineer Comments
The condensate waste pipe is preventing the removal of the condensate sump for cleaning.
The central heating timer selector switch on the boiler is missing/broken off.

Description: CH timer plastic selector switch missing.

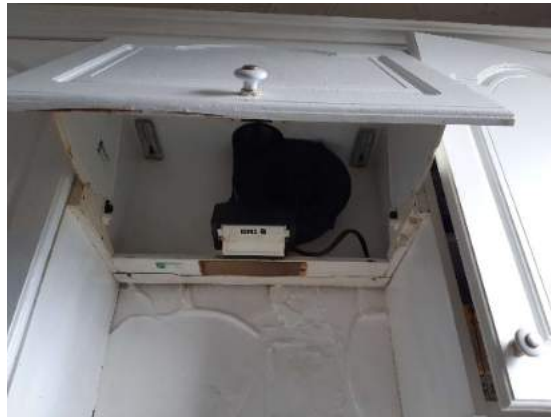
- The filter cover is missing.
- The oven door seal need replacing.
- The ignition generator is faulty, however, the hob is still safe to use.
-

Description: Cooker hood filter panel missing.
