Annual Electrical Safety Record - E2

Cert. No: CT-0111492-1533493001

INSTALLATION INSPECTION (Visual & Functional)

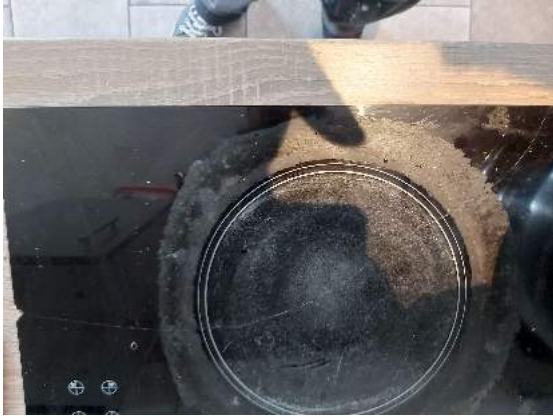
1		No	This Safety Record Issued By: Engineer Name:
2		No	
3	Glass cracked on front burner	No	
4		No	
5		No	
6		No	
7		No

Description: Cracked hob
